# **Unveiling the Immaterial: The Premier Wooden Building Restoration Project at The Hope Waddell Institution, Calabar**

This paper examines the restoration and preservation of the Premier Building at the Hope Waddell Training Institution in Calabar, Nigeria, a significant colonial-era educational structure. The study actively integrates both tangible and intangible elements into the restoration process, considering historical, cultural, and environmental factors that shaped the building's original construction and its current restoration. This project critically evaluates the practical application of conservation principles like the Venice Charter (1964). While some aspects of the theoretical framework were successfully implemented, others remain a work in progress, revealing the complexities of balancing historical authenticity with modern needs. This study offers a critical reflection on heritage conservation within a postcolonial context, highlighting both the challenges and potential of restoring colonial buildings in Africa as part of a broader effort to reclaim and reinterpret these structures for contemporary use.

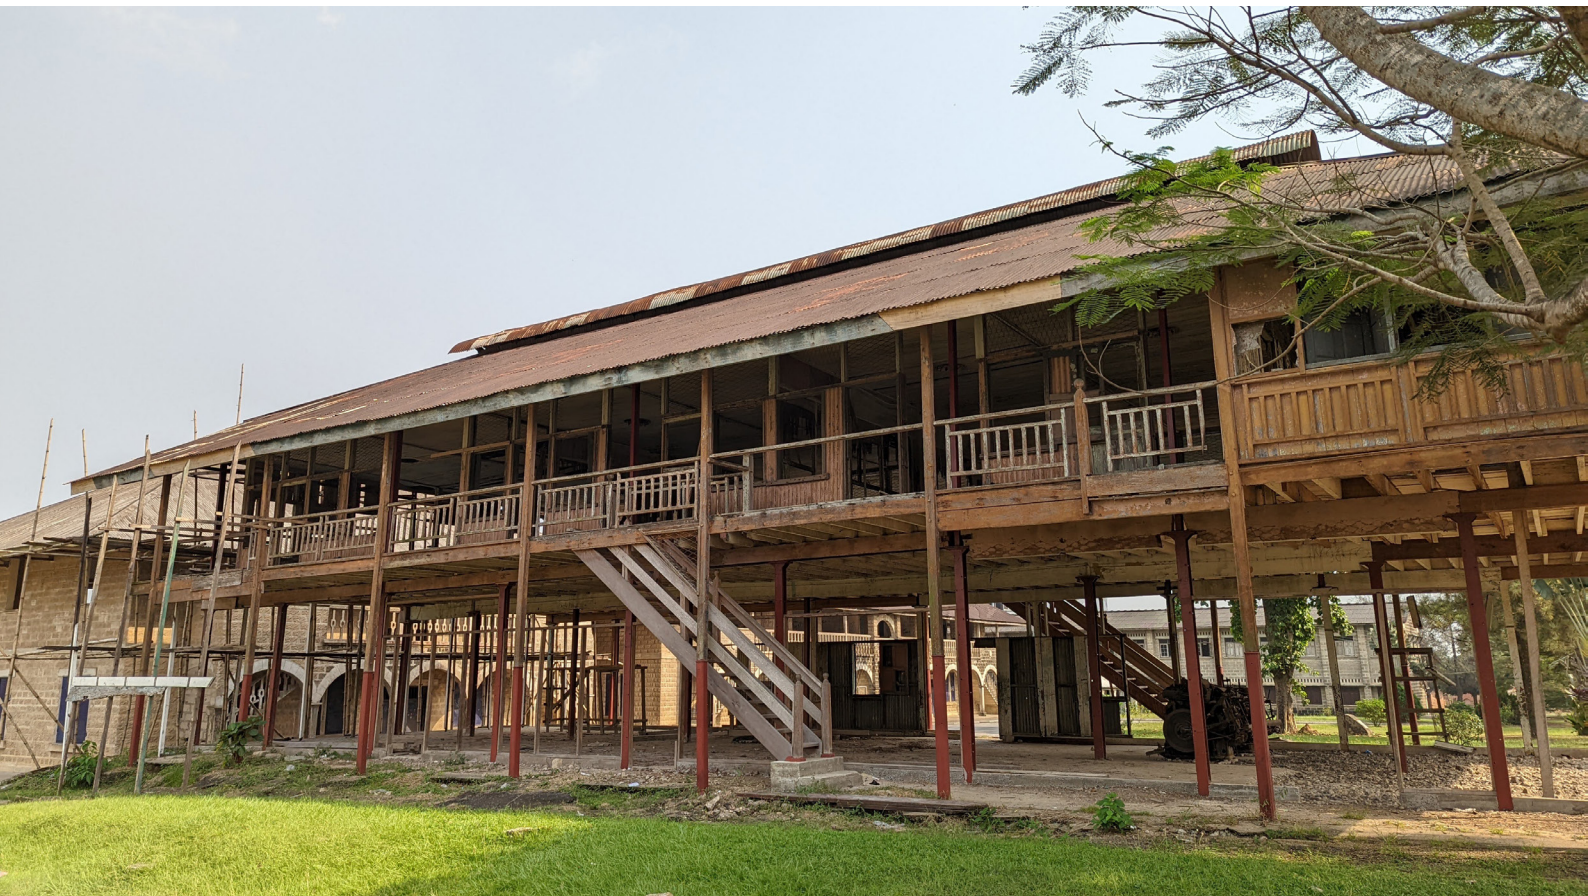
**Figure 1: Dilapidated state of the Premier Building in 2022. Photo taken by author.**

In response to this deterioration, the restoration team adopted a comprehensive approach that extended beyond mere technical repairs (Figure 1). It emphasised the integration of 'weightless' elements—such as community

The paper not only acknowledges the state of disrepair the Premier Building reached but also delves into the reasons behind its abandonment (Figure 1). A combination of shifting educational priorities, economic challenges, and the development of new facilities on the campus led to the building's gradual neglect. For instance, over the 130 years of the Hope Waddell Training Institution's evolution, several new buildings were constructed, including the Duke Town School Building (1899), Jubilee Building (1924), Science Building (1950), and Assembly Hall (1960), each reflecting the institution's changing needs and architectural trends (Figure 2). The rise of these newer facilities, constructed with materials like concrete and earth bricks, diminished the Premier Building's role on campus, rendering it a more peripheral structure by the early 2000s.

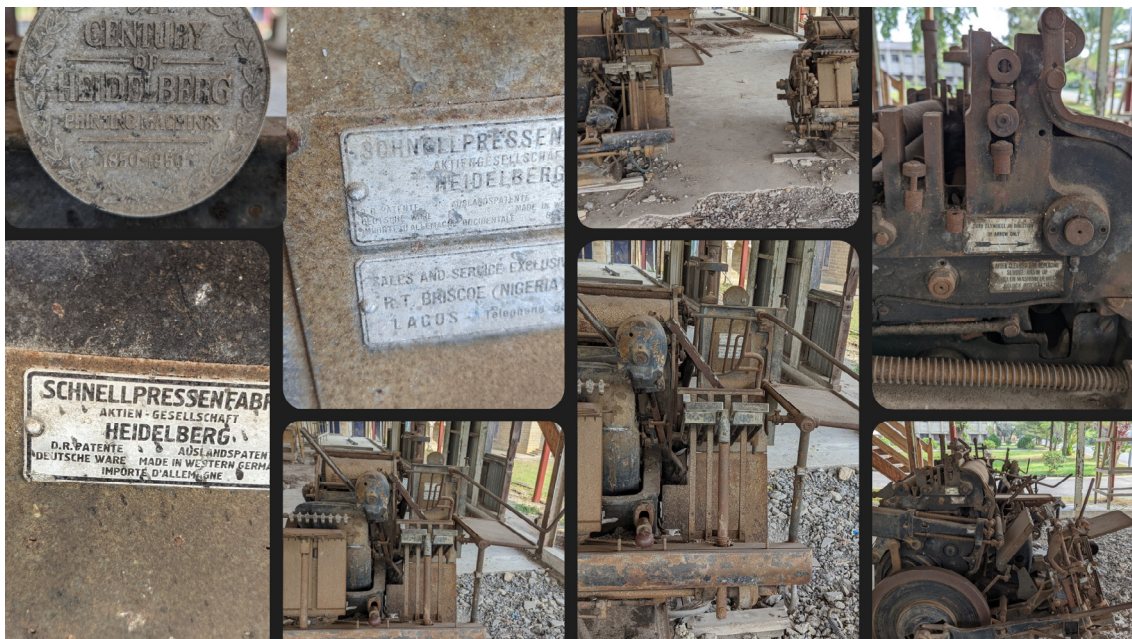
**Figure 3: This image collage features close-up views of an old Heidelberg printing press machine, a historical artifact located in the Premier Building at the Hope Waddell Training Institution in Calabar, Nigeria. The various angles showcase the intricate mechanical components of the press, reflecting its industrial craftsmanship and the robust engineering typical of early 20th-century printing technology. Photos taken by Author in 2022.**

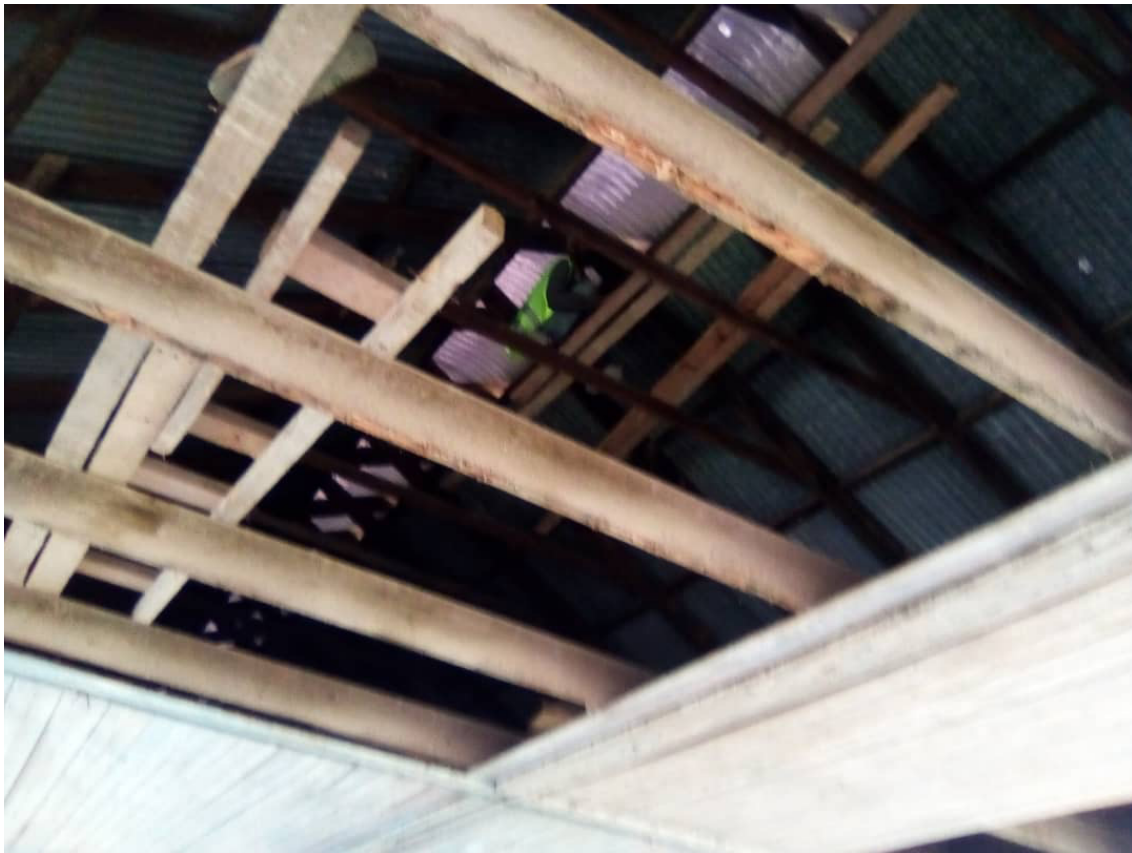
**Figure 4: The artisans working on the felt underlay in the roof of the Premier Building. Photo taken by the author, 2023**

This included the addition of a felt underlay beneath the corrugated sheets, a technique that improves thermal insulation and reduces heat gain—thereby making the interior spaces more comfortable in Calabar’s hot and humid environment. This intervention is philosophically aligned with the Venice Charter’s allowance for modern materials and techniques when necessary to preserve a monument’s functionality and ensure its continued use. The restoration project

engaged local artisans to implement these roofing enhancements, thereby integrating traditional craftsmanship into the process (see fig. 4). This approach reflects a philosophical commitment to respecting and revitalizing local building practices, which aligns with the Charter’s emphasis on involving local communities in conservation efforts. By combining traditional methods with modern improvements, the project aimed to create a roof system that not only preserves the building’s historical appearance but also meets contemporary standards of comfort and durability. The strategic use of both traditional and modern roofing

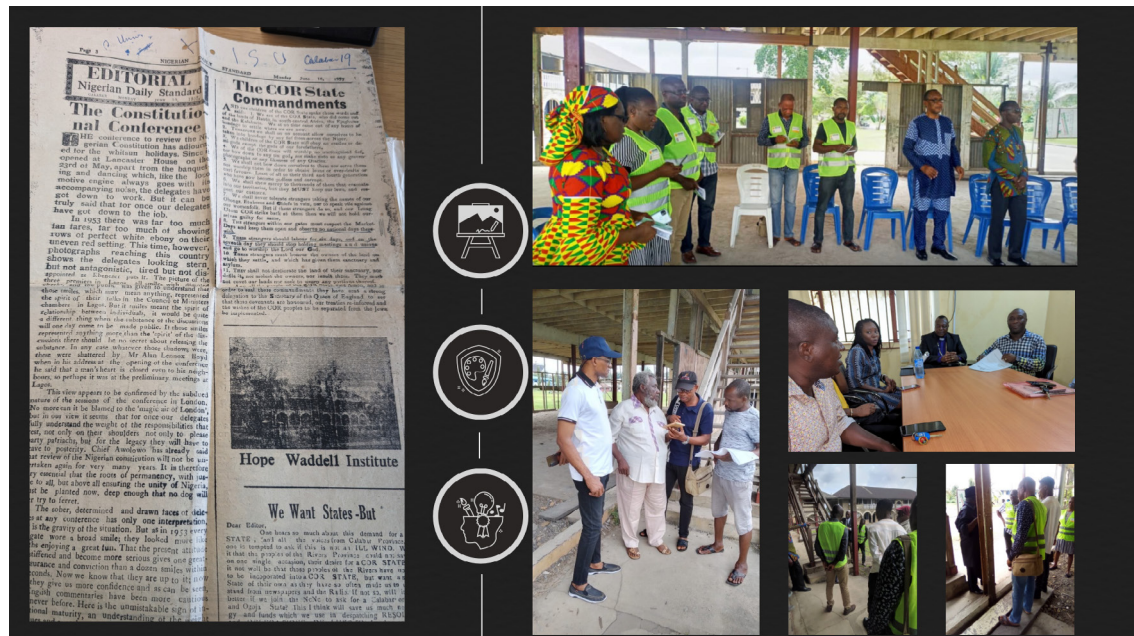
**Figure 5:** This image collage presents a visual narrative centred around the Hope Waddell Training Institution, combining historical documentation with contemporary restoration efforts. The collage is divided into sections that showcase archival materials, ongoing restoration activities, and discussions among stakeholders, alumni and community members. Photos taken by Author in 2022/2023 and collage created by Author in 2024.

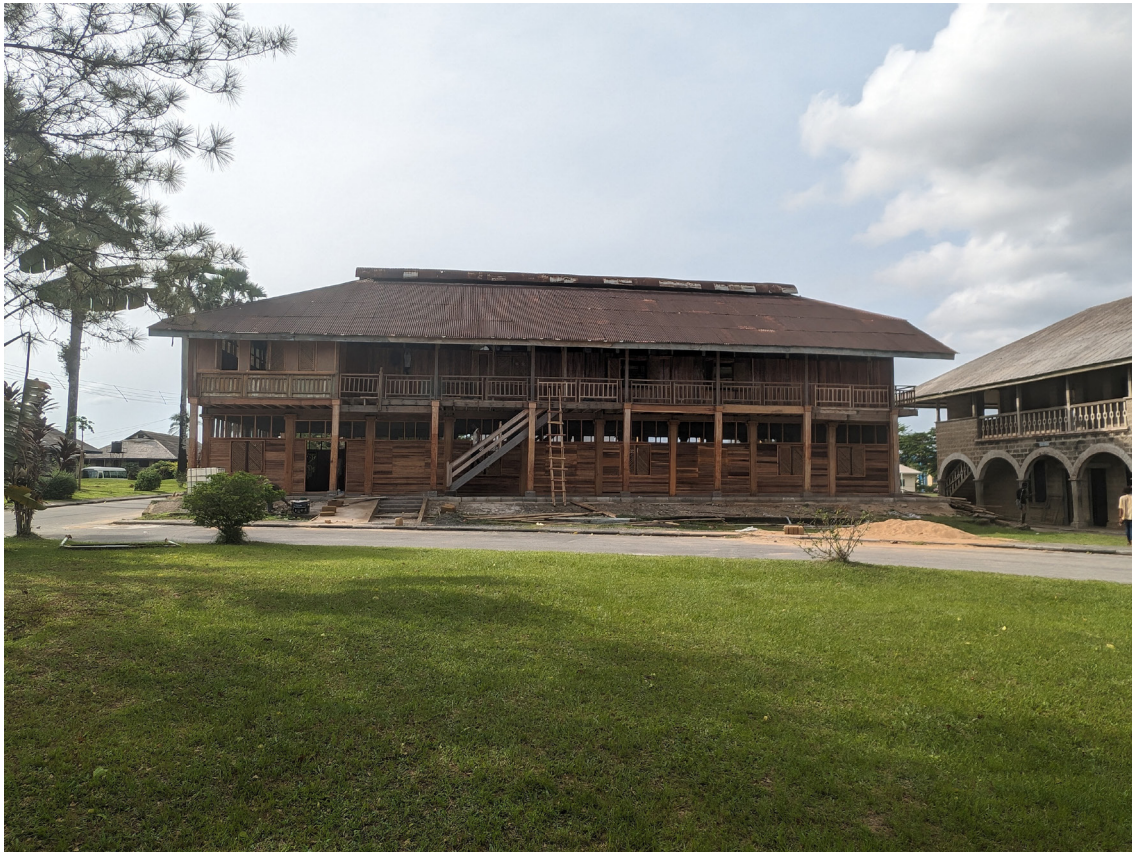
**Figure 6: Restored Premier Building. Photo taken by Author in 2024**
